CHURCH OF THE HOLY SEPULCHRE JERUSALEM

STRUCTURAL SURVEY
FINAL REPORT

WILLIAM HARVEY

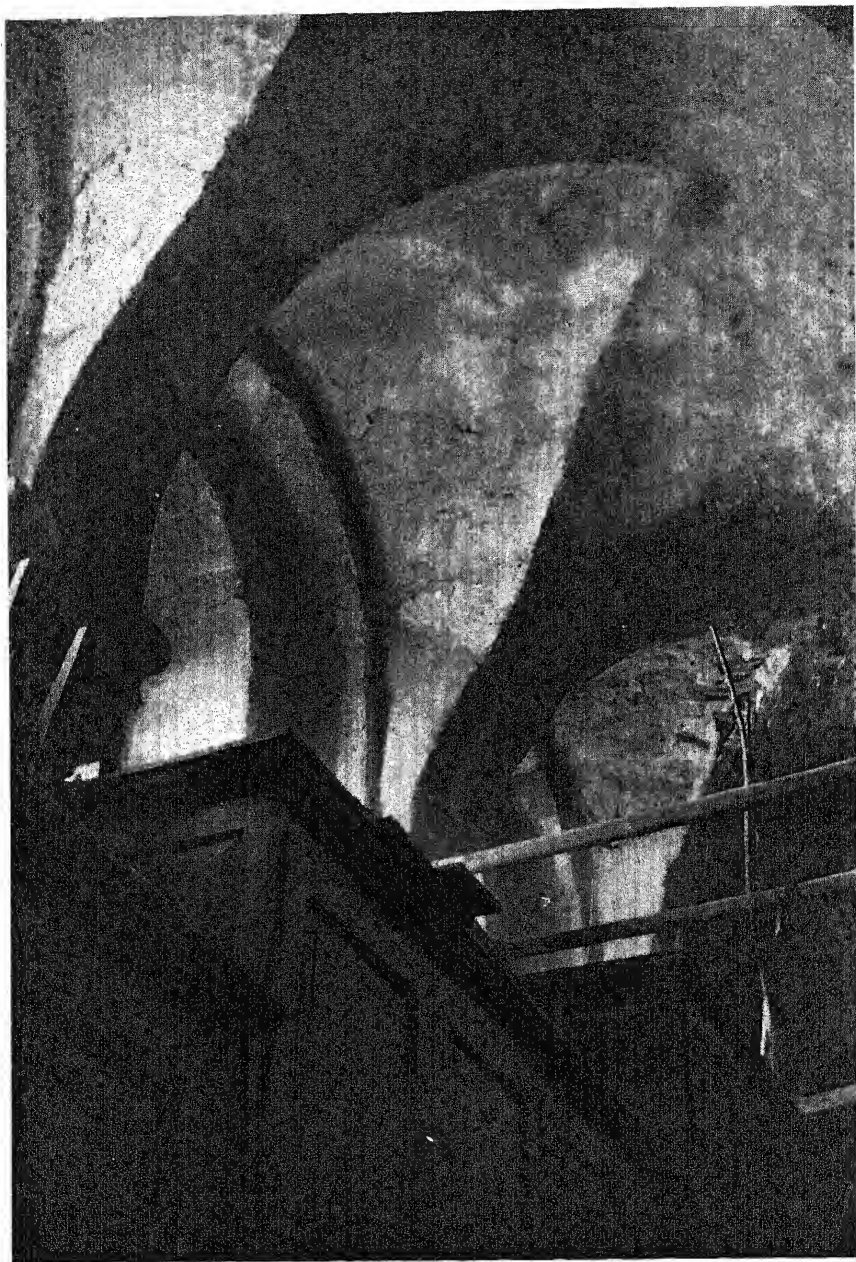
During plastering which took place eighteen months ago, it was found that the vault of the upper gallery was not in contact with the outer wall in many places (see Fig. 10); the very large cracks then visible are now hidden by the new plaster, but within the last few months the plasterwork has again shown cracks in the same positions as the hidden defects, thus indicating that movement is now continuing. The carved stone capitals of the attached half-columns supporting this vault are badly cracked owing to the pressure and torsion to which they are subjected.

FIG. 10. VAULT OF NORTH TRANSEPT UPPER GALLERY—
BEFORE RE-PLASTERING

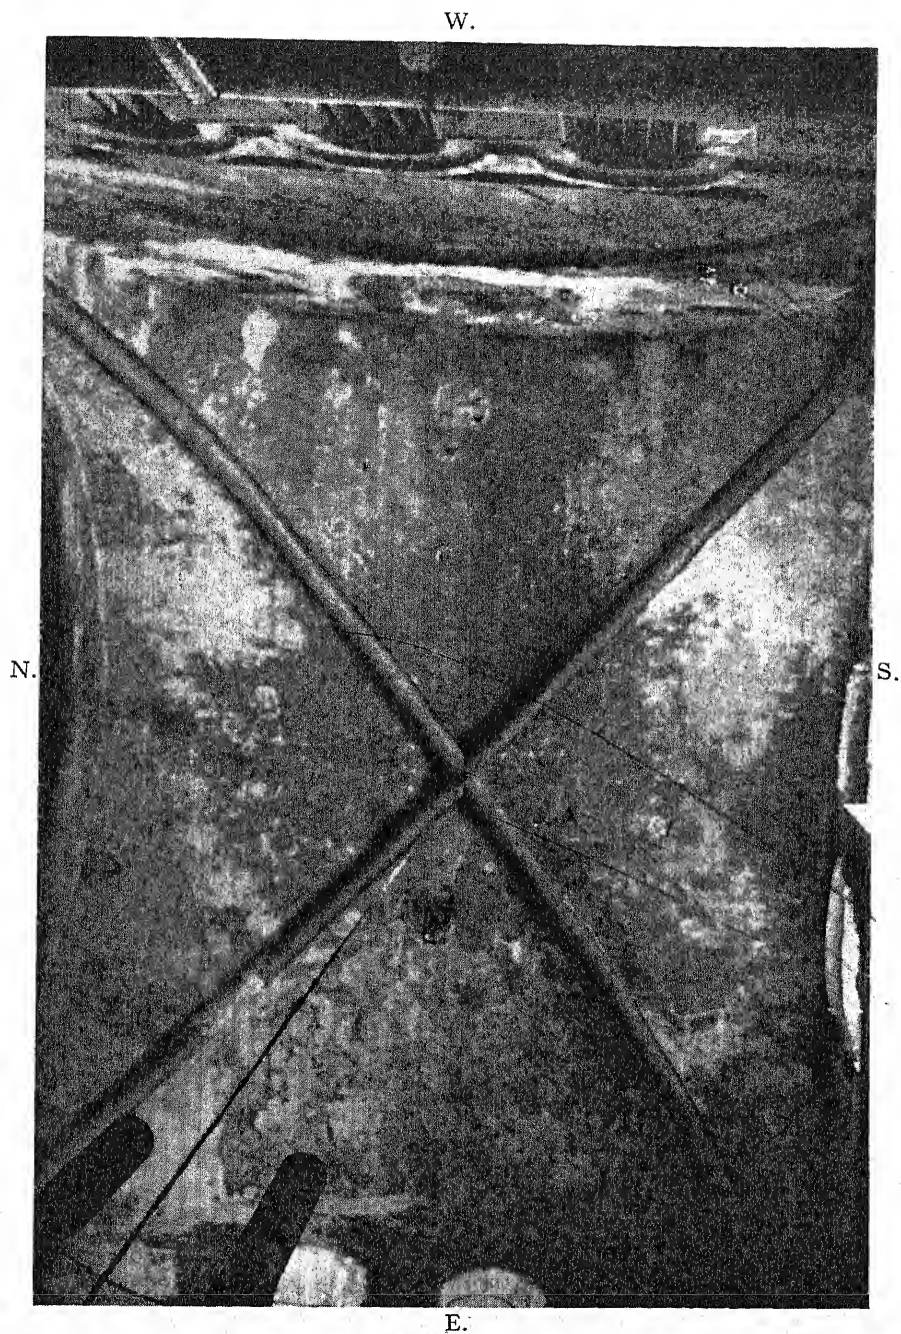
FIG. 23. SOUTH TRANSEPT VAULT

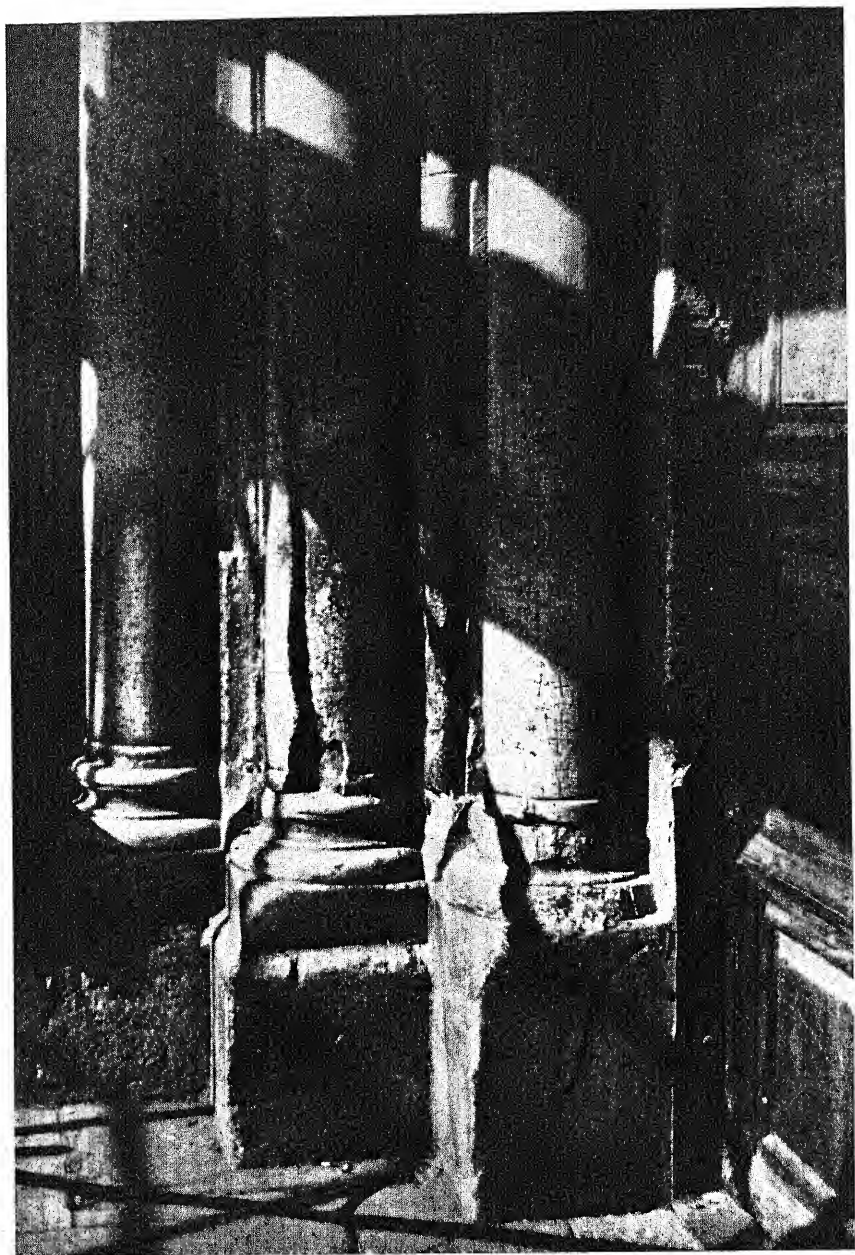
The lower colonnettes and their bases are almost all cracked, the oblique direction of the cracks showing the asymmetrical loading of the arches above (see Fig. 24). The condition of most of the carved work is extremely good (see Figs. 25, 26, 27, 28, 29) with the exception of the inner orders of the upper arches, which suffered most from the fire (see Figs. 30, 31, 32).

FIG. 24. BASES TO W. OF MAIN DOOR

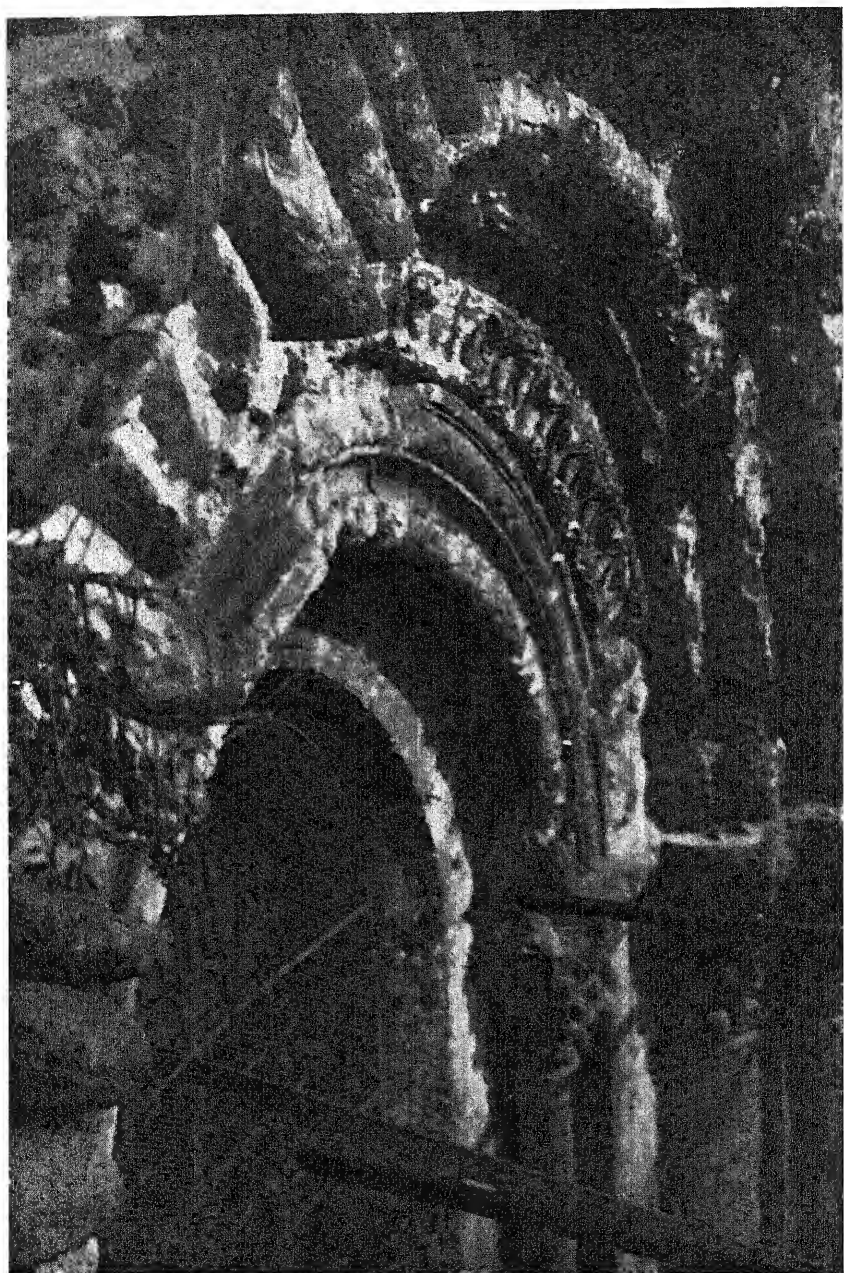
FIG. 30. UPPER ARCHES OF FRONT

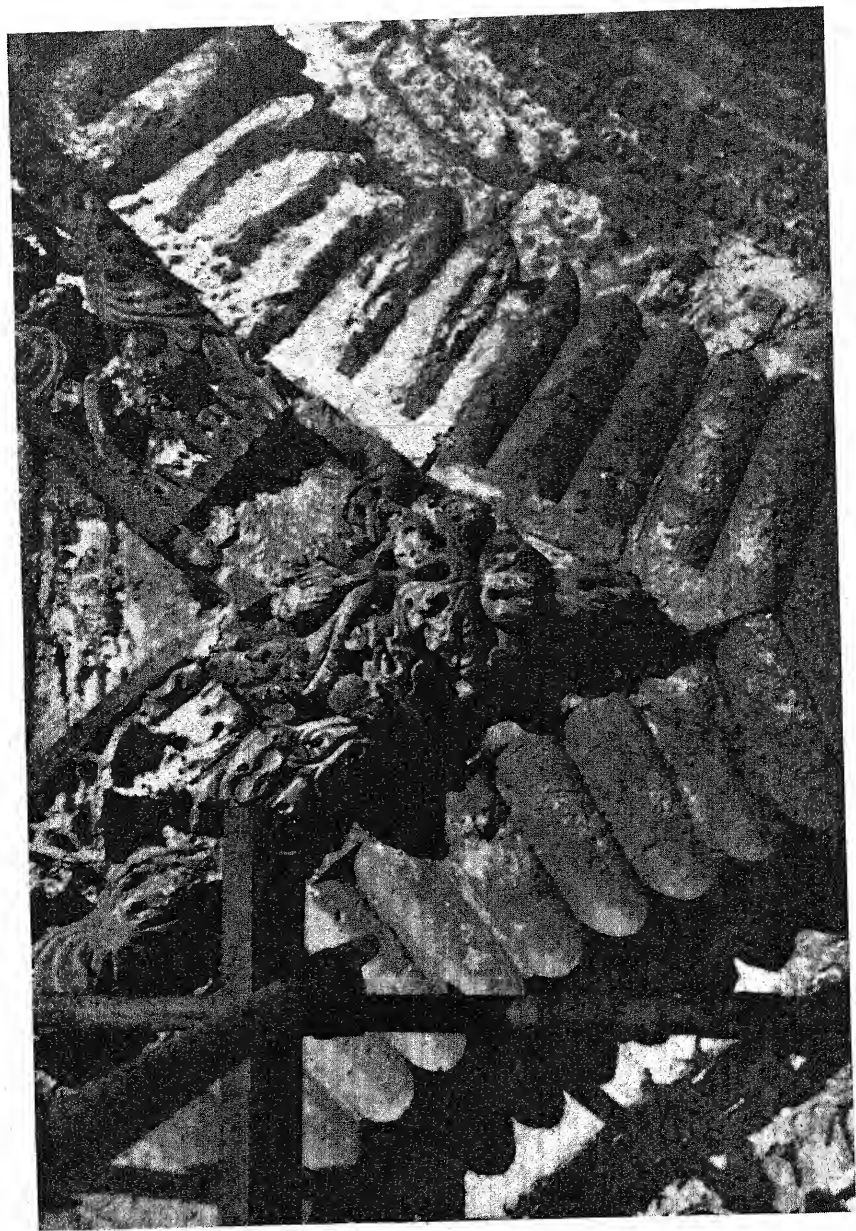
FIG. 32. SPANDREL CARVING OF UPPER STRING-COURSE OVER WINDOWS

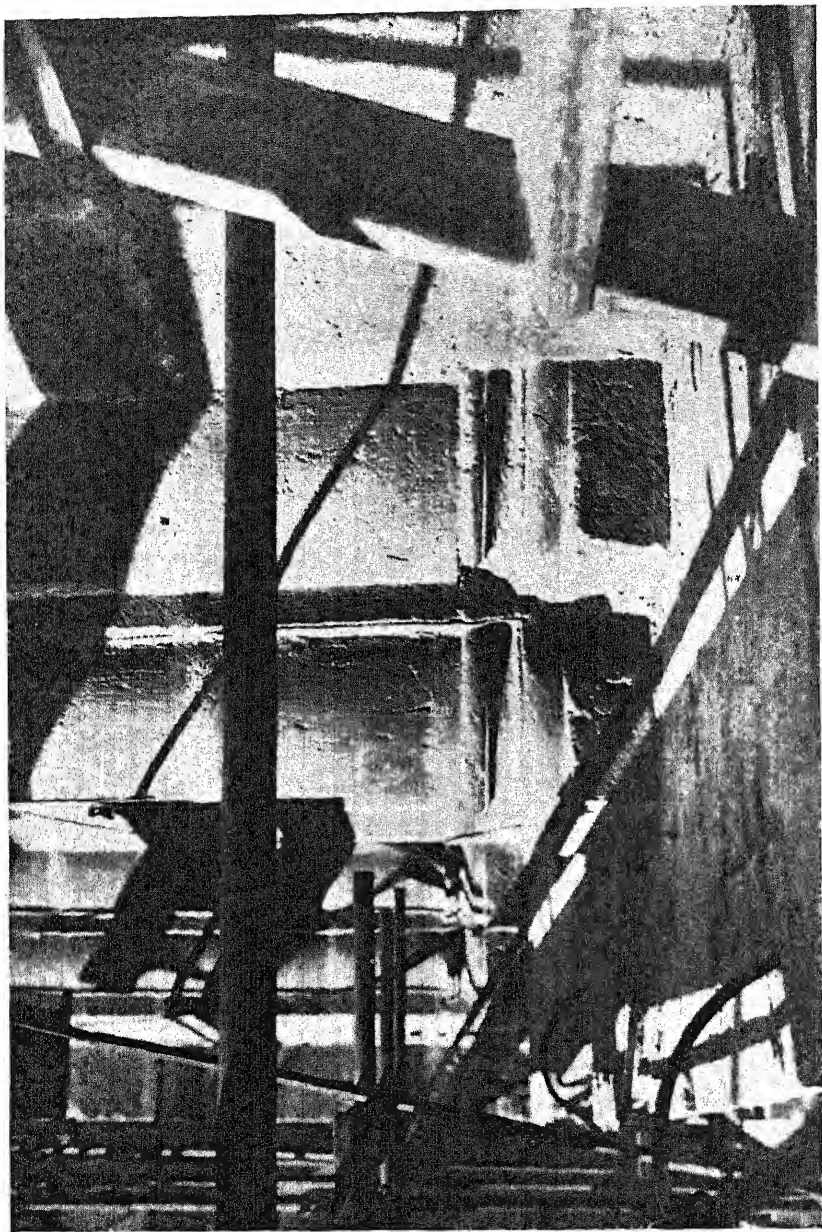
Serious cracks occur both from the outside of the wall (see Fig. 36) and in the attached pier within (see Fig. 37); while others between the vault and the wall have been covered by plaster (see Fig. 38) (see also Additional Notes, pp. 13 and 15).

FIG. 36. CRACKED BASES OF PIERS OF UPPER ARCADE

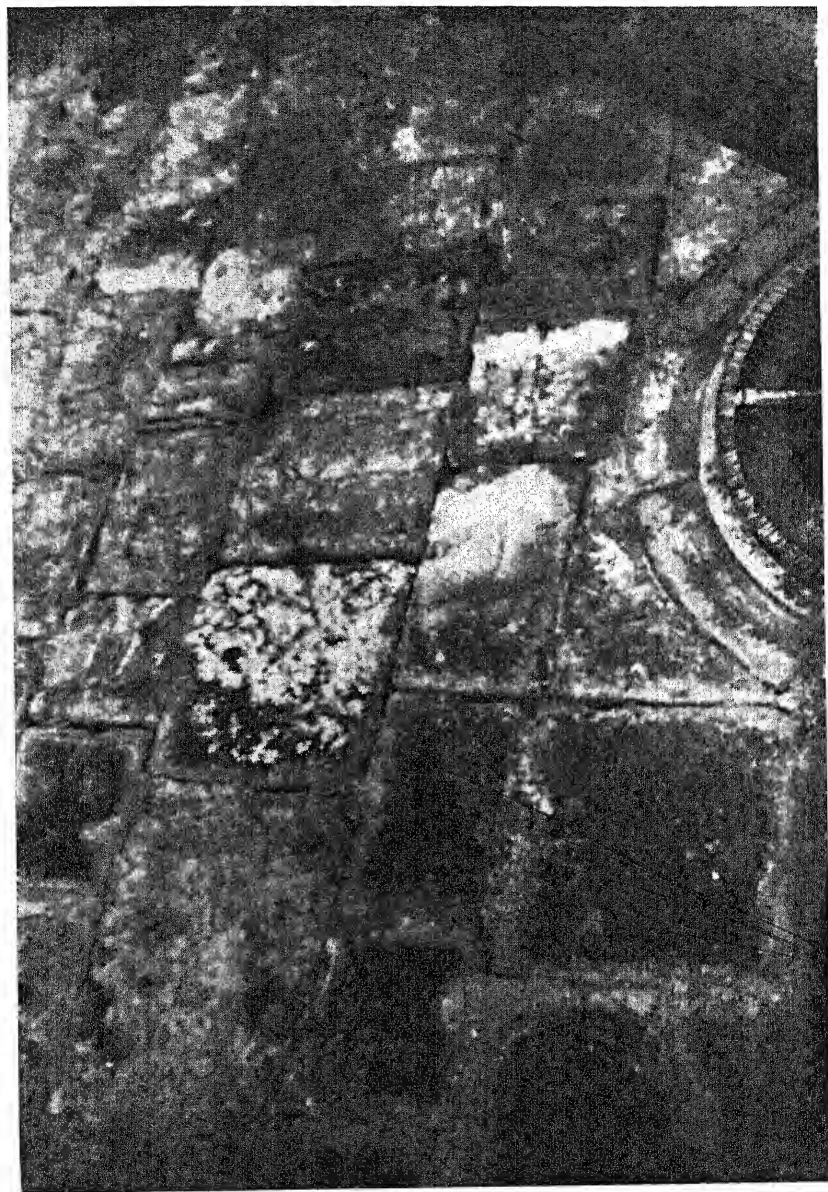
FIG. 36a. SOUTH TRANSEPT HIGH VAULT E. WALL TO SHOW FRACTURES
IN MASONRY AND JOINTS

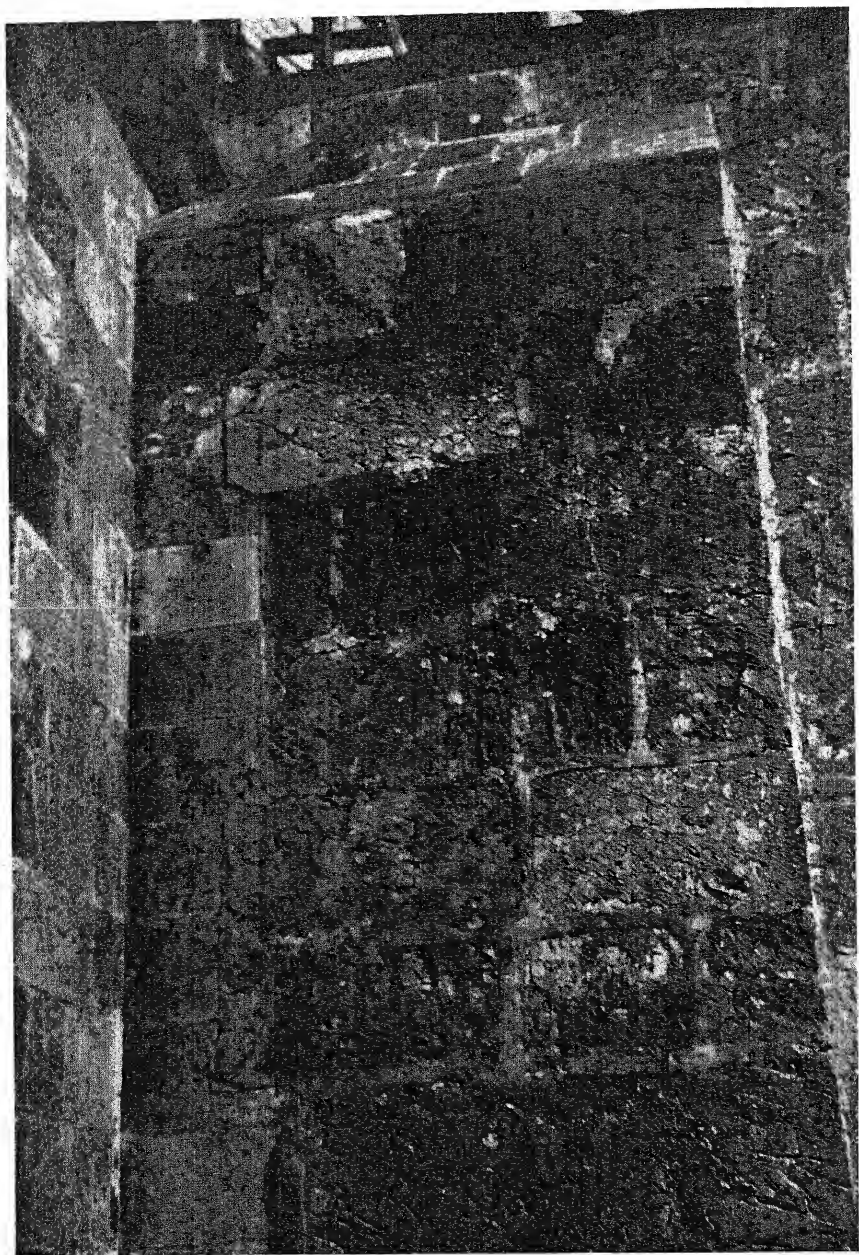
FIG. 36b. SOUTH TRANSEPT HIGH VAULT W. WALL
TO SHOW CRACK

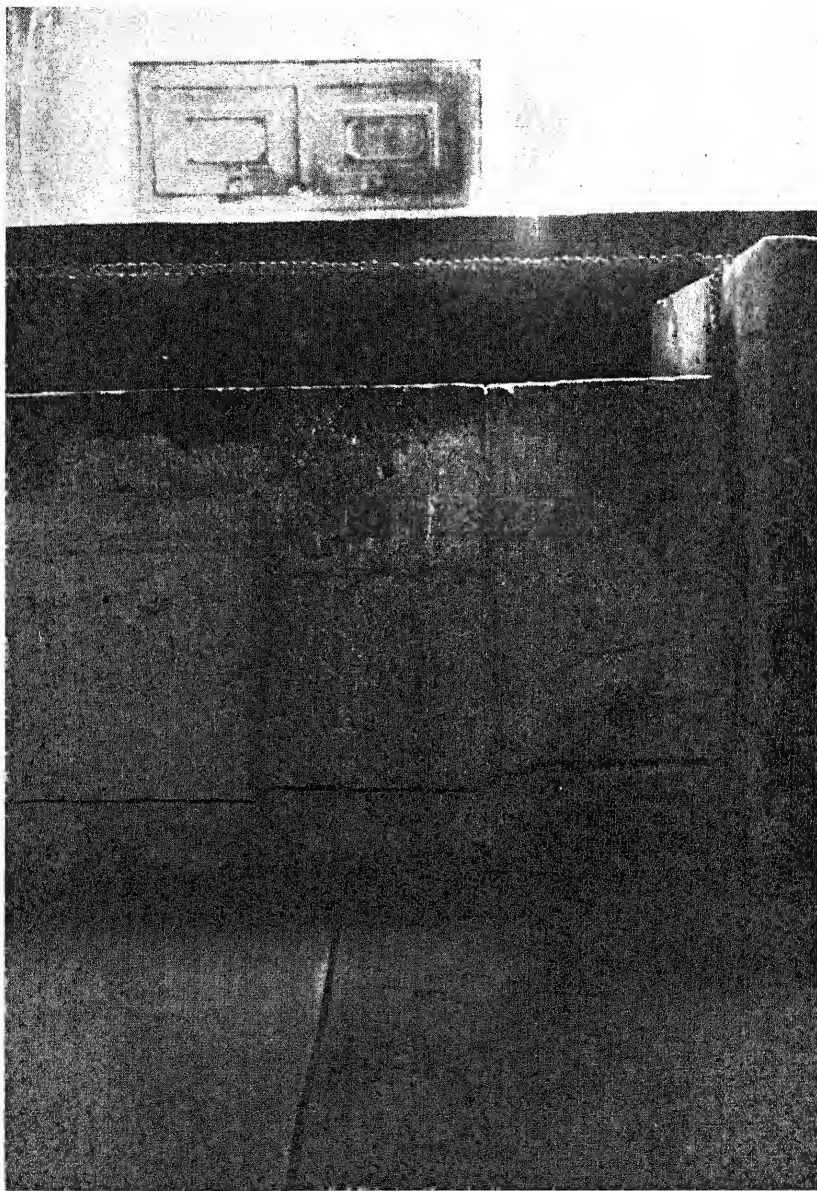
FIG. 37. FRACTURE IN ATTACHED PIER BETWEEN MAIN DOORS

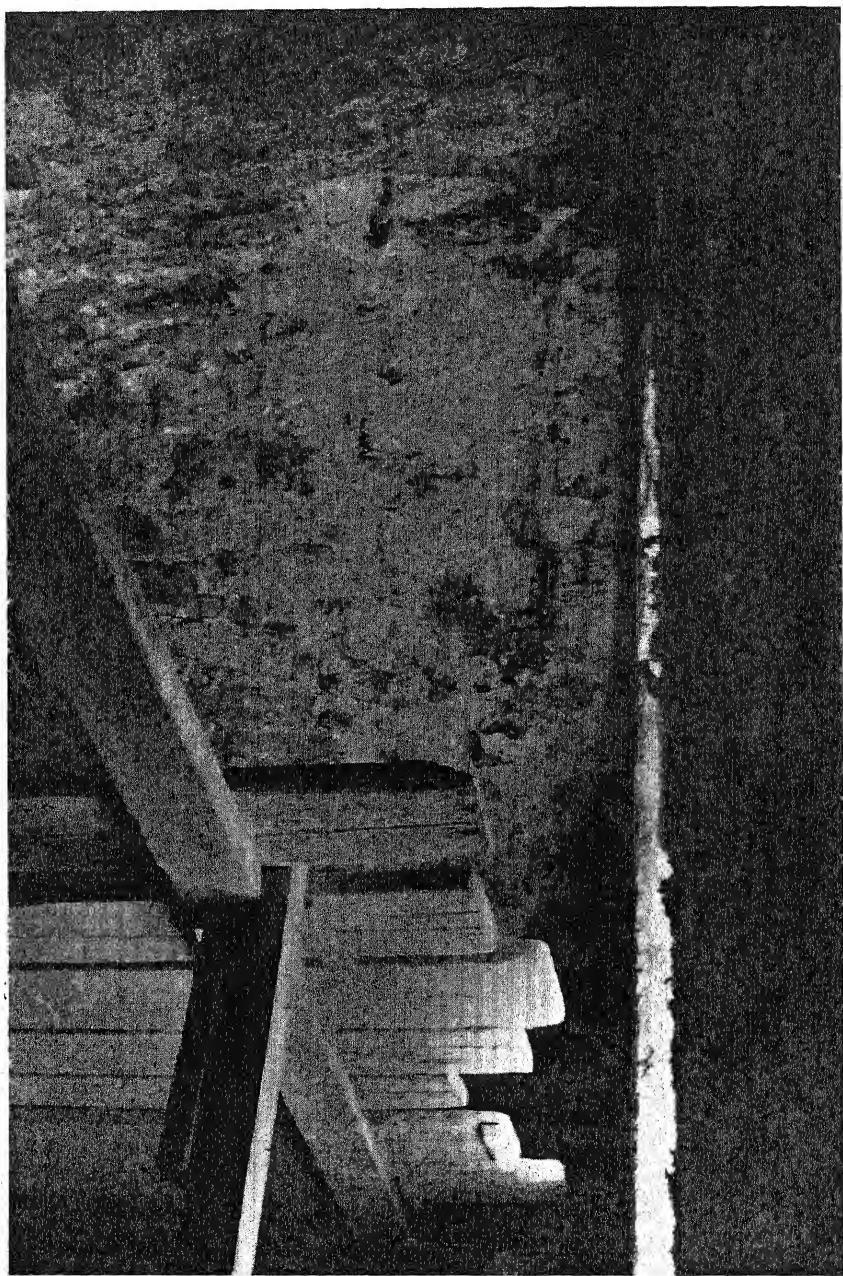
FIG. 38. CRACKED VAULT OF ARMENIAN GALLERY
BEFORE RE-PLASTERING

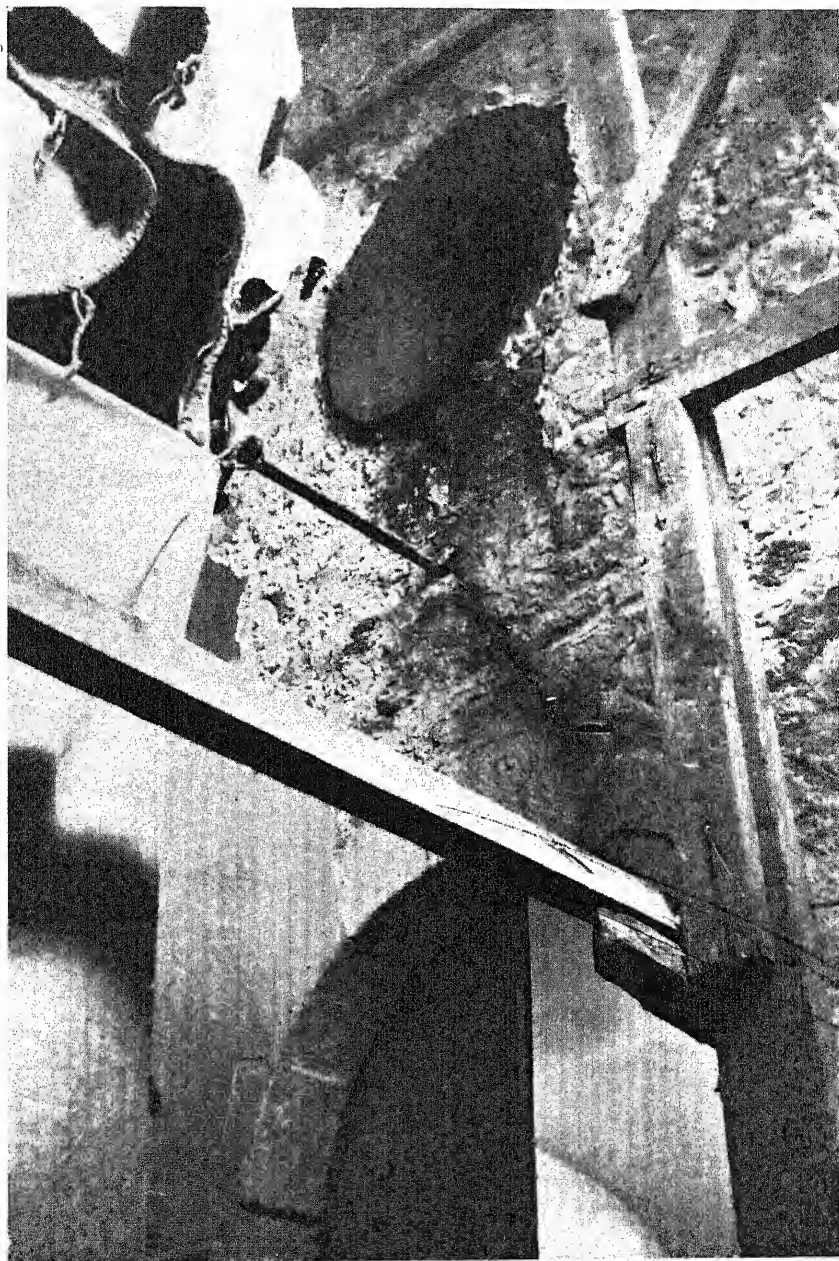
FIG. 38a. CRACK IN TRANSVERSE WALL OF ARMENIAN GALLERY
BEFORE RE-PLASTERING

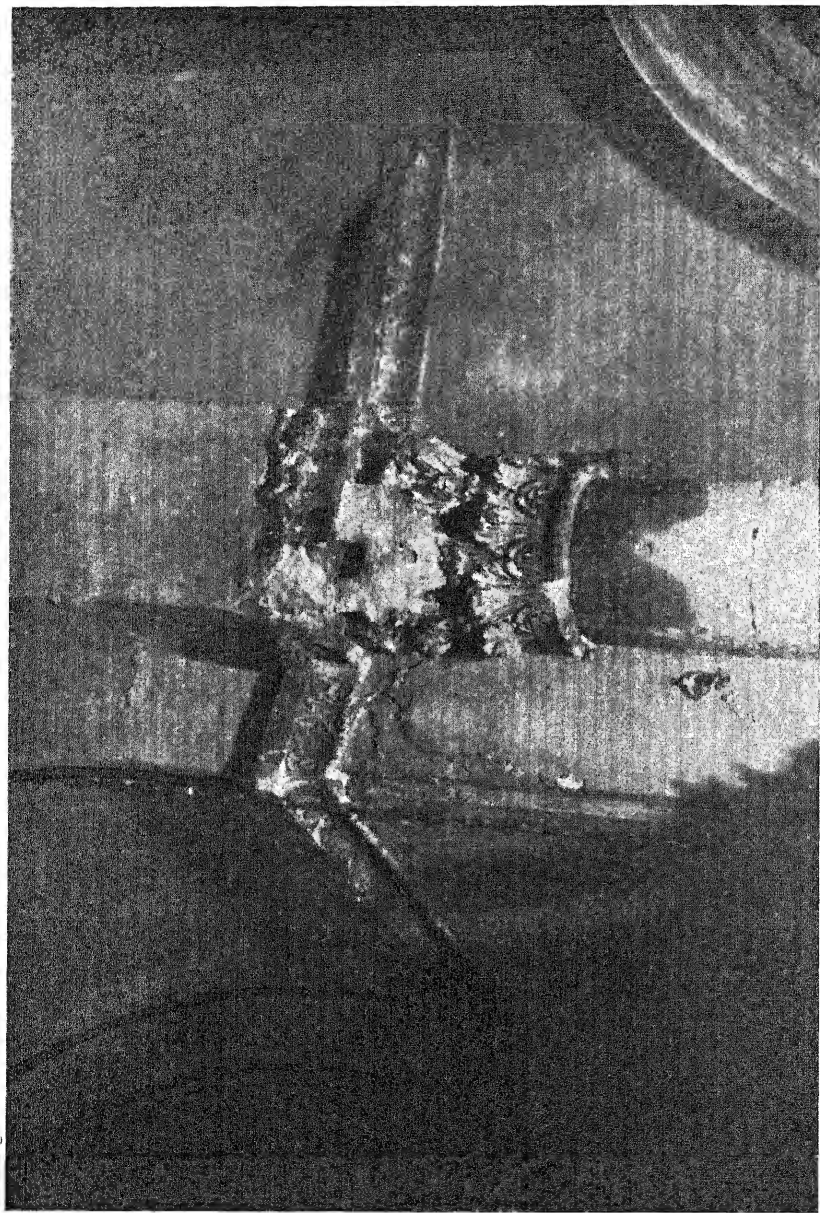
FIG. 43. CAPITAL DAMAGED RECENTLY. AMBULATORY

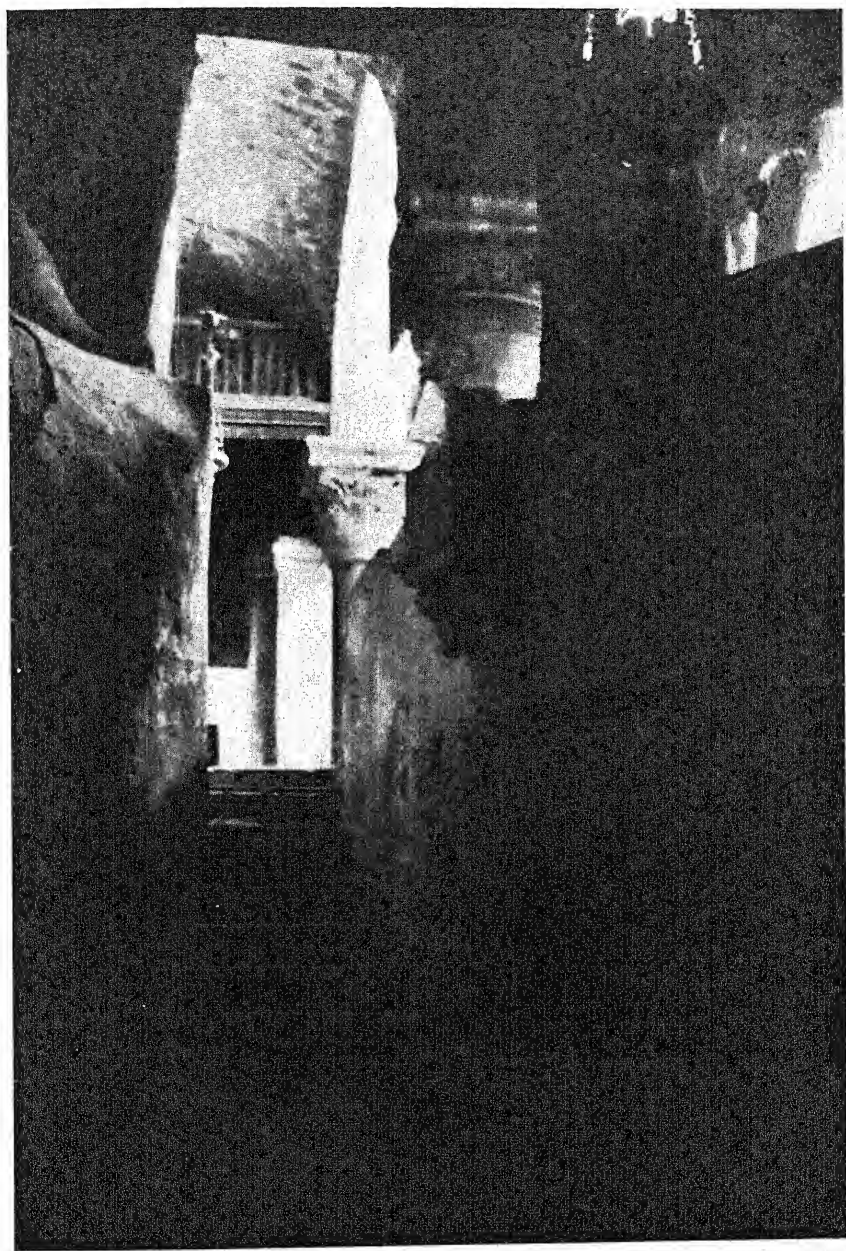
decay of structural consequence. The dome (see Fig. 46) leaks and requires water-proofing outside, as the rough-cast stucco has become badly cracked (see Fig. 47). The floor is in a bad state, also the flight of steps leading to the Grotto of the Invention (see Fig. 48); these are at present covered with iron gratings.

FIG. 48. STAIR TO GROTTA OF THE INVENTION

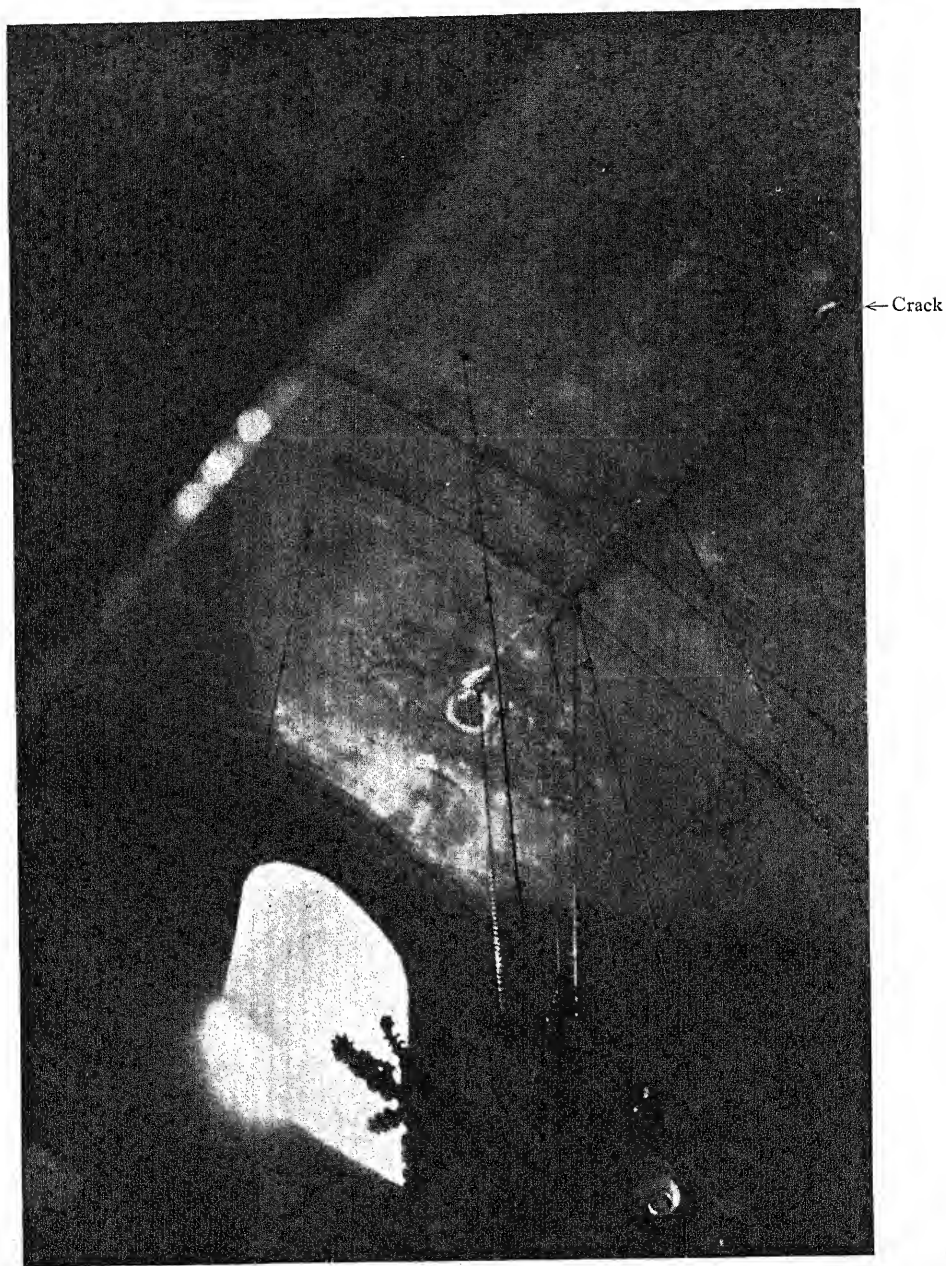
by $22\frac{1}{2}$ centimetres, and the crown of the vault is cracked throughout its length (see Figs. 63, V).

FIG. 63. VAULT OF CHAPEL OF ST. JAMES

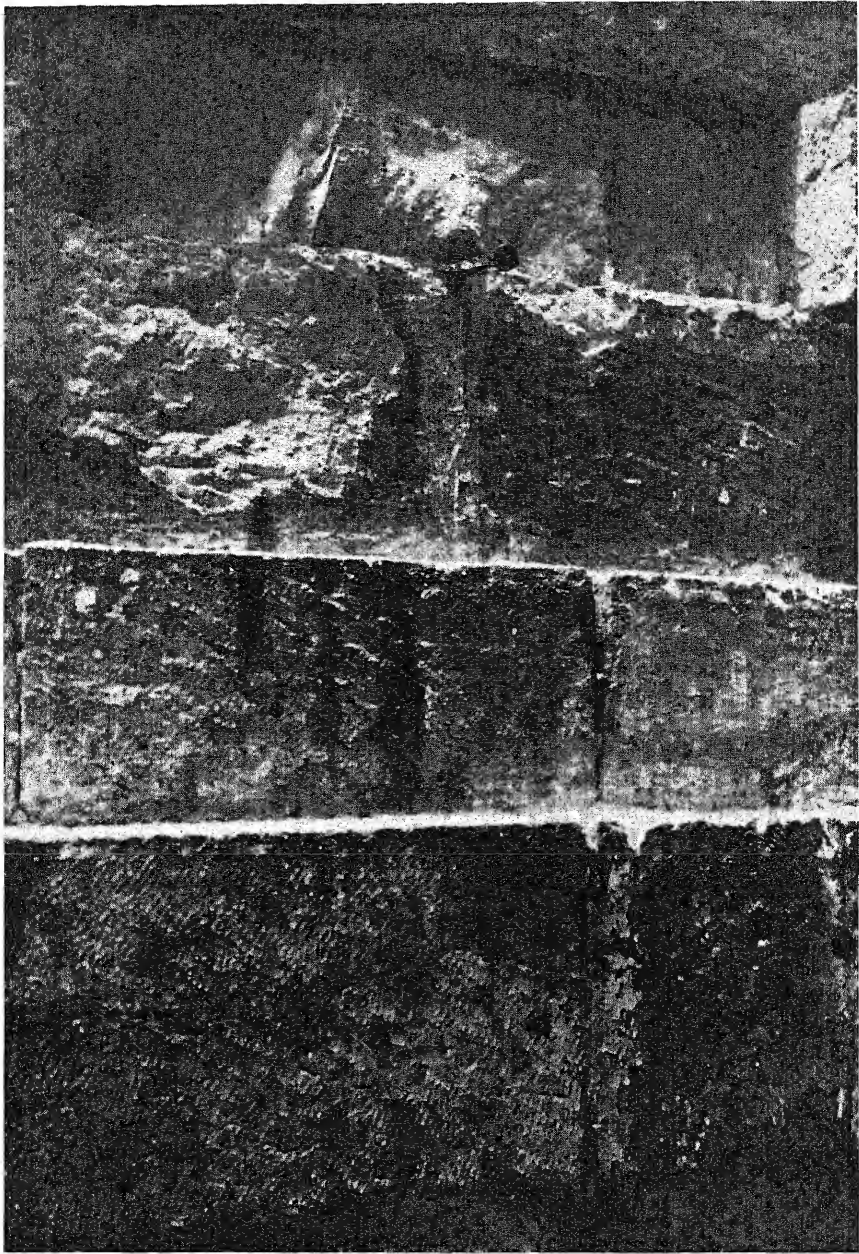
FIG. 65. FRACTURES DUE TO RUSTING IRON CRAMPS.
ROTUNDA PIERS

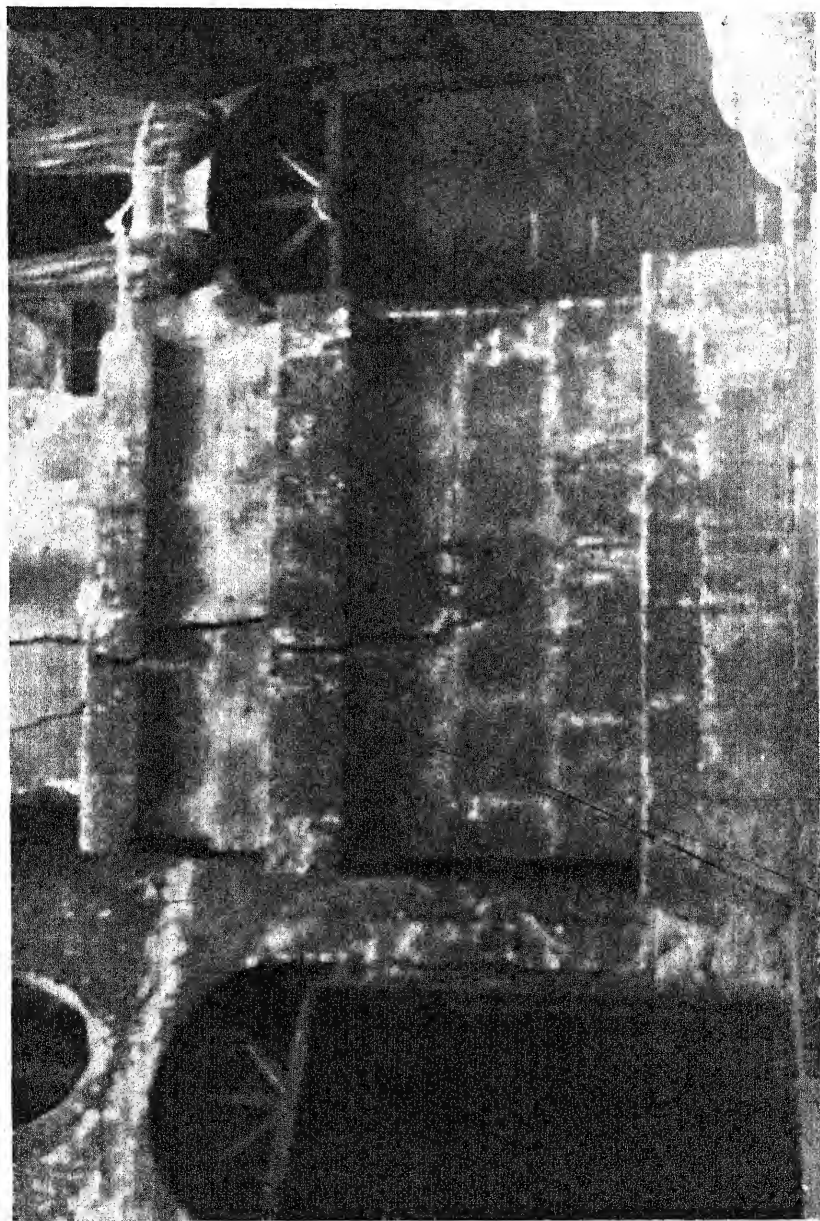
The piers of the main Rotunda (see Fig. I, 13) are now square (see Fig. 64), though they probably enclose as a core the earlier round columns of the building of Constantine Monomach (c. A.D. 1048). The present piers are clamped together with rusting iron (see Fig. 65), are very irregular in shape and size, and are not placed symmetrically beneath the circular drum built in 1867. They are therefore subject to eccentric loading, and all of them show cracks to a greater or less extent; some of these cracks are serious, though certainly due to earthquake shock as well as to thrusts (see Fig. 66).

FIG. 66. FRACTURED PIER AT W. OF ROTUNDA
